Asset Management Plans PART C Buildings Facilities

Essential Services Commission Higher Rate Cap Application 2017-18

Borough of Queenscliffe Building Asset Management & Condition Review

Borough of Queenscliffe Public Toilet Strategy 2015 – 2025 Supporting Document

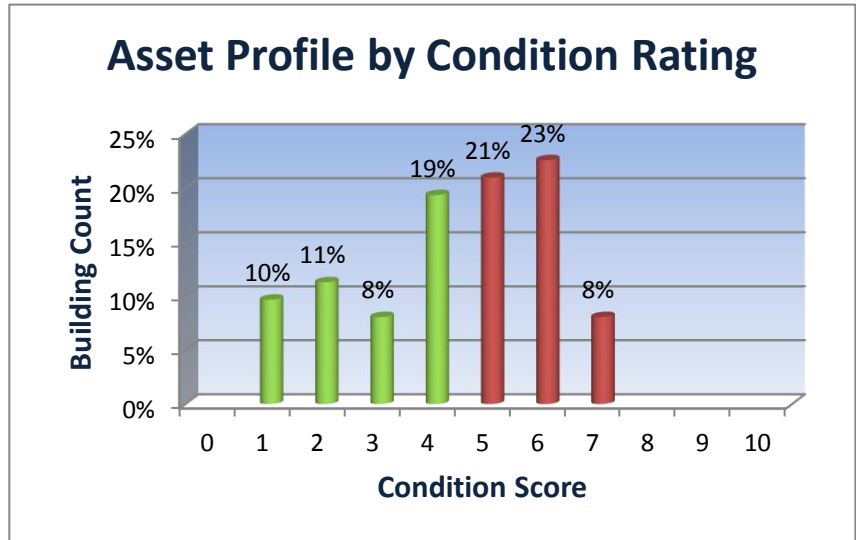
*Chart 2
Building
Condition Profile*

The Chart also identifies that 8% (condition 7) are near the end of their practical life and urgent renewal works will be required over the next 1-5 years. Prior to any major renewal works (significant expenditure) it is recommended that Council undertake a strategic review and determine the services it requires and the facilities it needs to deliver those services; i.e. undertakes a detailed needs analysis.

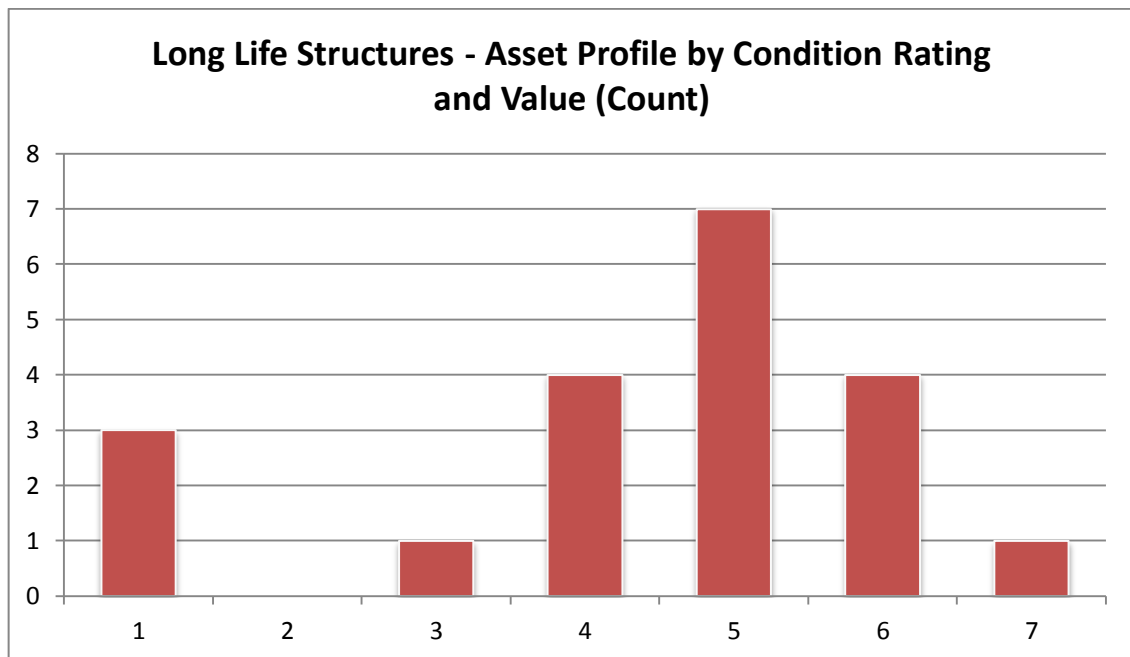
Long Life Structures - Asset Profile by Condition Rating and Value (Count)

The Chart identifies that the majority of buildings are in average condition (4-6) with 3 like new and 1 in need of review. Since 2010 it was observed that buildings are showing signs of deterioration mainly attributed to the gradual ageing of the buildings.

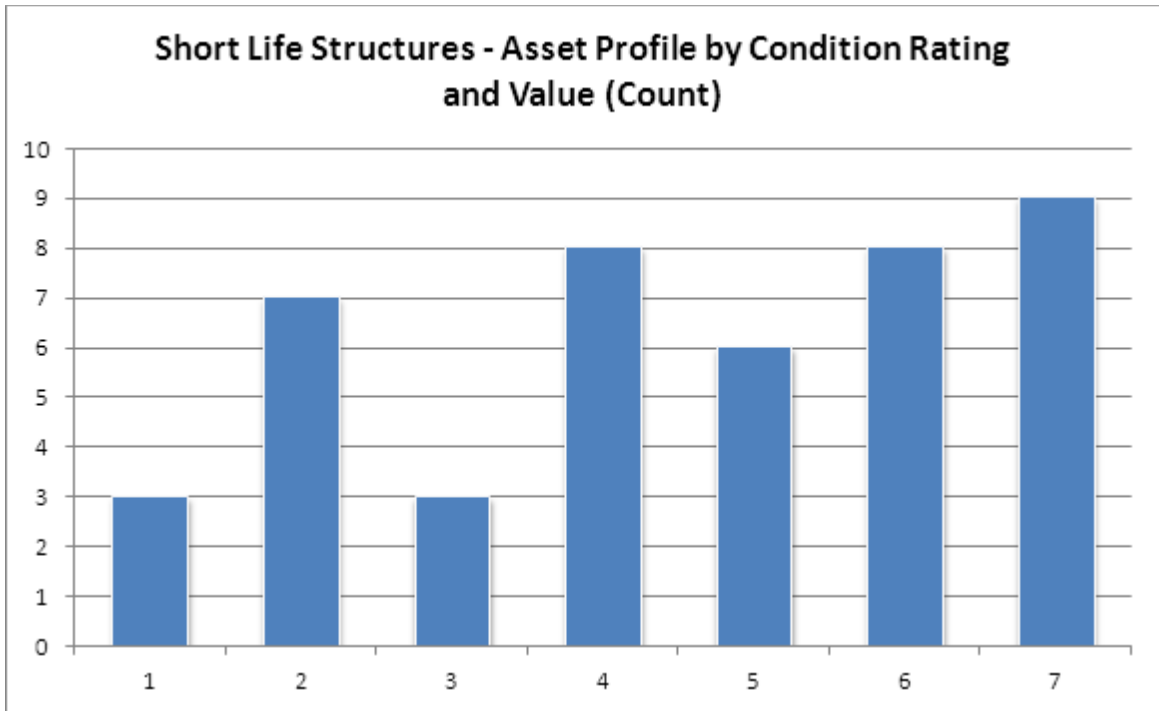
Chart 5:
Structure Short
Life Condition
Profile

As distinct from the Long Life Structures spread of Condition ratings the Short Life Structures Chart shows 9 buildings (20%) of short life structures in condition 7 (poor). The structural components of these buildings are now reaching the end of their functional life and will need careful assessment of their potential replacement or renewal in the near future.

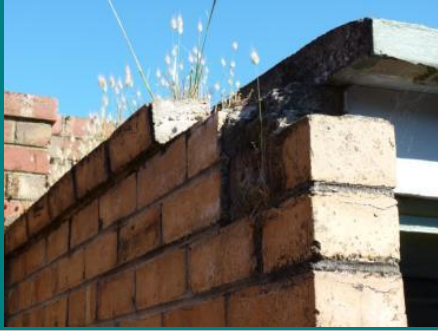
<p>Toilet Block & Kiosk (Princess Park)</p> <p>ID 71 – Loose bricks top of wall, Ladies dressing area. Remove loose bricks and relay with new mortar.</p>

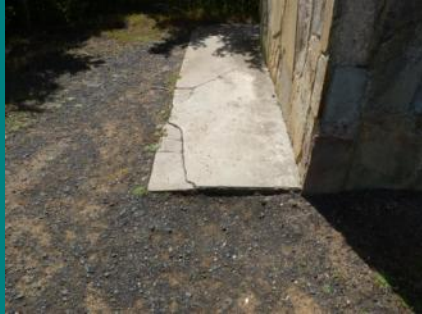
<p>Toilet Block Toch</p> <p>ID 241 – Trip Hazard at both entrances. Replace damaged slabs and bring crushed rock level up to finished concrete level</p>

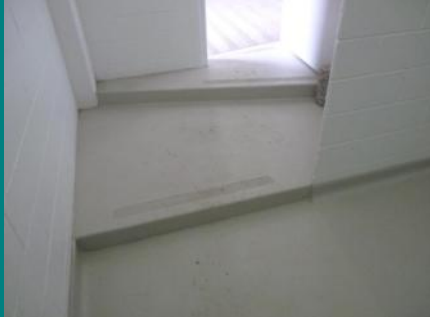
<p>Queenscliffe Rec Res Monohan Sporting Complex</p> <p>ID 171 – Trip hazard lower ground to Ladies and Men’s dressing rooms. Apply painted visual strip along length of steps.</p>

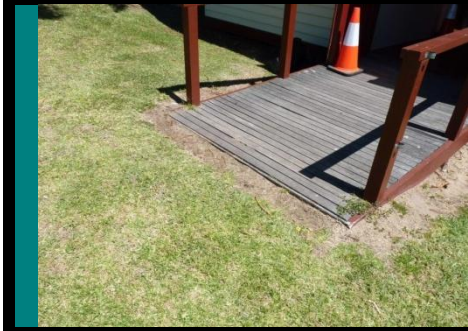
Pavilion (Lower Princess Park) Market

ID 48 – Trip hazard. Top up with soil to avoid sudden drop off.

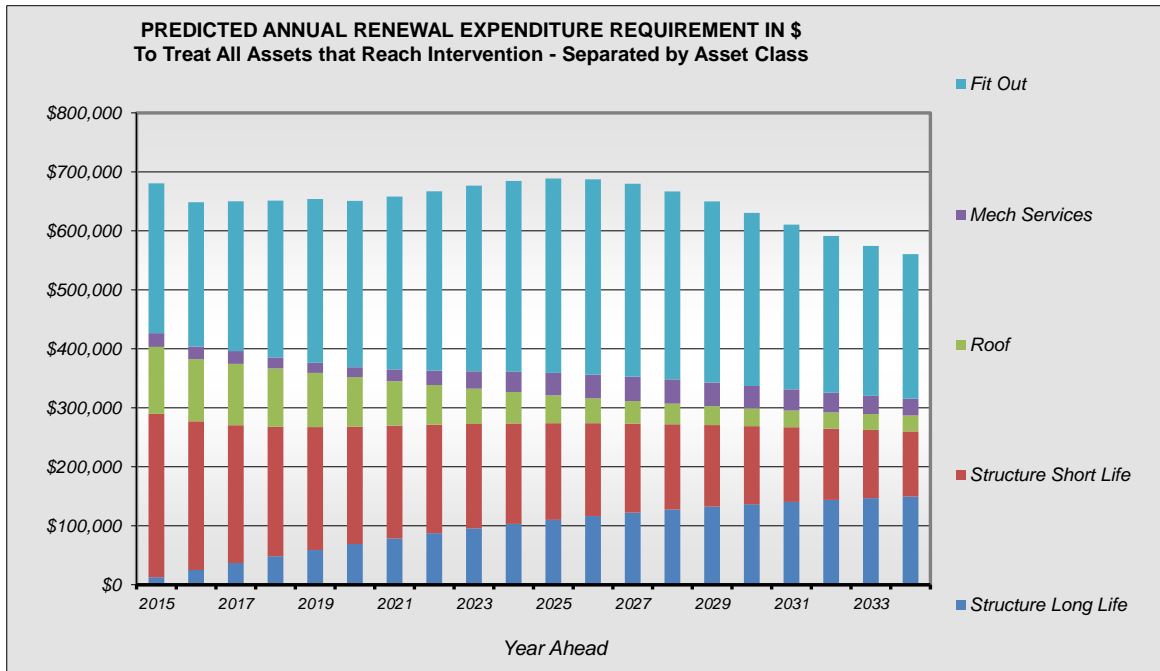
Chart 12
Predicted Required
Capital Expenditure
2015 – 2035 by
component

Utilising the CT Management Program with Moloney’s AM modelling program, data was populated into a Data Input format and the modelling outputs for all 64 buildings are as follows:

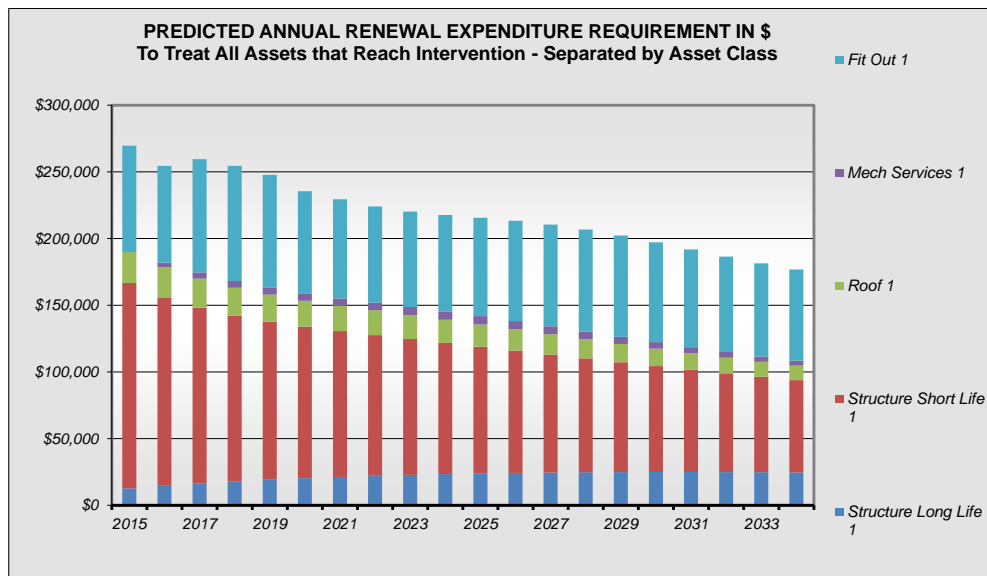
Chart 13
Predicted Required
Capital Expenditure
2015 – 2035 by
component
Foreshore Buildings

Chart 13 demonstrates the renewal funding requirements for the retention of all the designated foreshore buildings for the next 20 years. It demonstrates a higher demand in the early years and steadily decreasing over time. This indicates that that many of these assets are in average to poor condition and need renewal. On average the chart indicates renewal needs of ~ \$200,000 per annum is required if these buildings are retained in the long term, with a nominated renewal intervention value (condition).

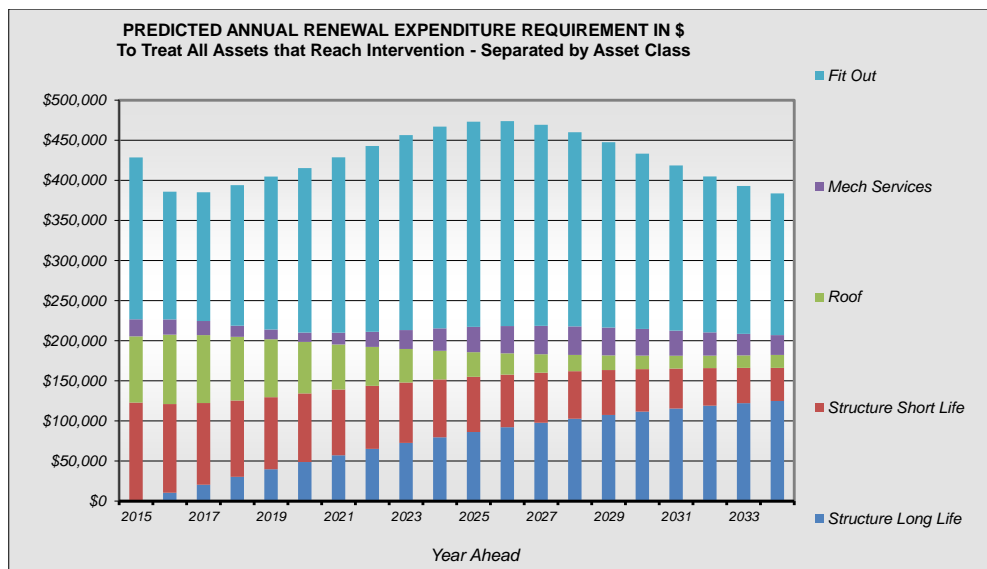
Chart 14
Predicted Required
Capital Expenditure
2015 – 2035 by
component
Council Buildings

Chart 14 below demonstrates the renewal funding requirements for the retention of all the designated Council buildings for the next 20 years. It demonstrates a steady demand of ~ \$400,000 per annum for renewal if these buildings are retained in the long term, with a nominated renewal intervention value (condition).

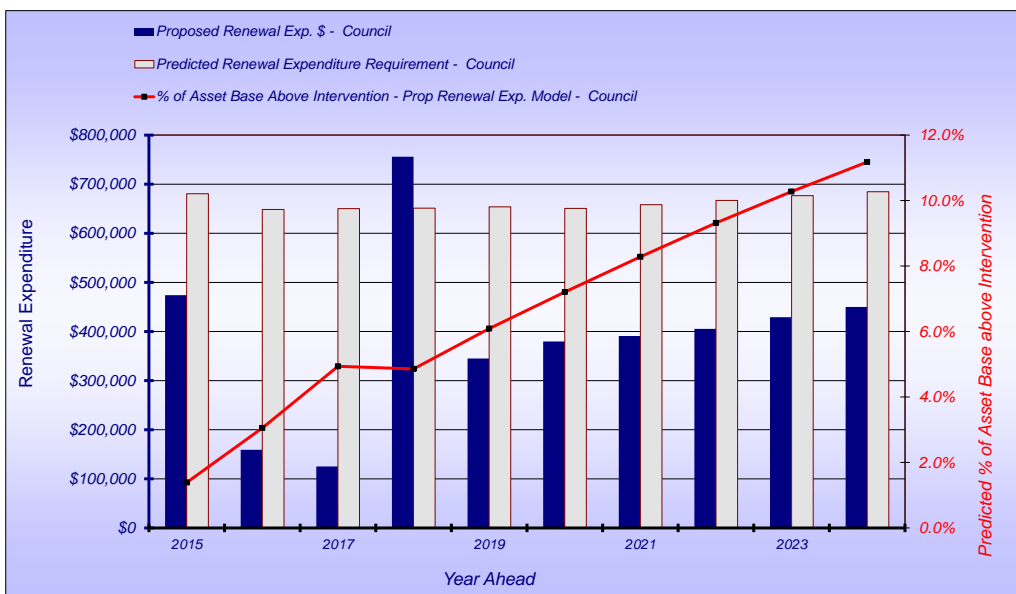
Chart 15
Proposed Renewal Exp and Predicted Renewal Expenditure. Required Capital Expenditure 2015 – 2025

Chart 15 highlights the current proposed renewal expenditure (dark Blue column) as designated within Councils LTFP. The grey columns indicate the required renewal expenditure for each year (predicted at around \$650,000). The red line is the predicted overall condition of all the buildings based on the proposed renewal funding levels. As evidenced in the Chart currently less than 2% of buildings and their components are at or above the desired intervention (condition) level. Within 5 years this is predicted to rise to ~ 6% and by the year 2025 11%.

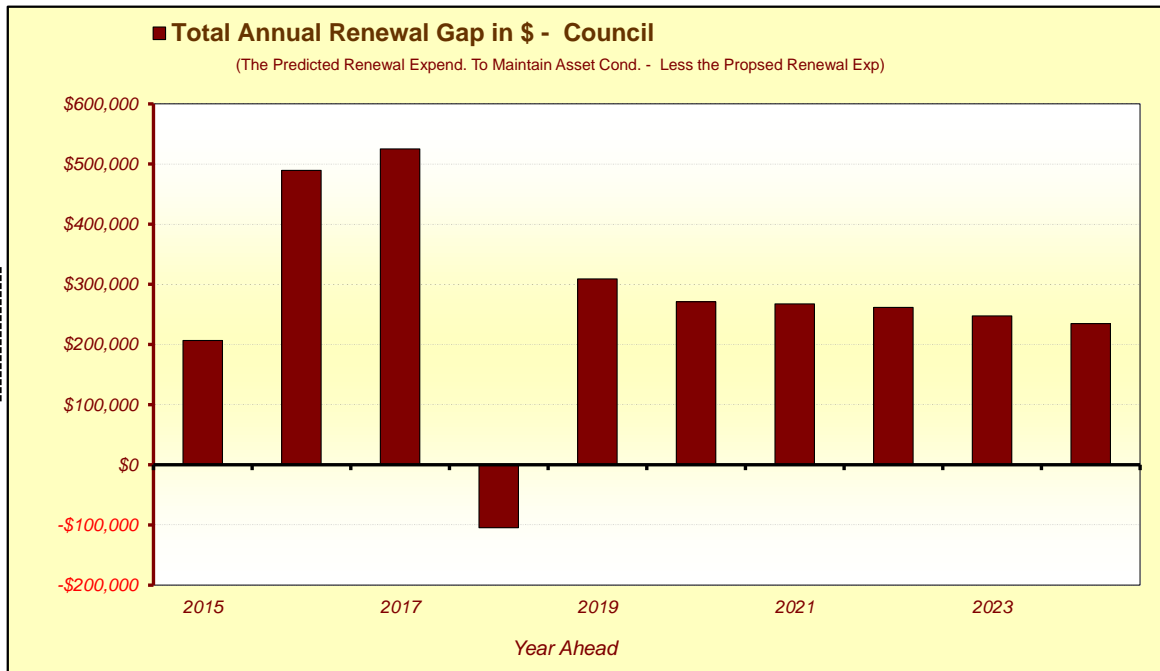
Chart 16
Predicted Annual
Renewal Gap
2015 – 2025

Chart 16 is one of the principle outputs of the modelling, identifying the **shortfall** in renewal funding if current expenditure patterns, as designated within Council current LTFP, continue. The model forecasts that for 2015/2016 an additional \$200,000 is required and increases to \$500,000 in years 2-3. The excess funding in 2018 is due the large funding within that year. Overall Council currently has a predicted cumulative gap of \$2.7M over the 10 year period resulting in an average annual renewal funding shortfall of \$270,000.

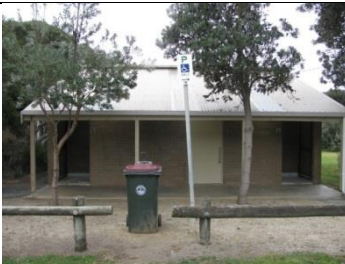
Toilet No 9 –Ganes Reserve - Ocean Road, Point Lonsdale

Style	Stand Alone - Traditional with Unisex Disabled cubicle direct access
	Age	Newer
	Cubicles	4Female, 3Male, 1 Urinal, 1Unisex Disabled,
	Other Facilities	Change Table/bench (Female)
	Open	24 Hours/day

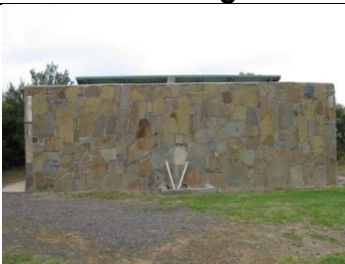
Toilet No 11 –Light House Reserve – Point Lonsdale Road, Point Lonsdale

Style	Stand Alone - Traditional
	Age	Very Old
	Cubicles	2Female, 1Male, 1 Urinal, (No Disabled)
	Other Facilities	None
	Open	24 Hours/day

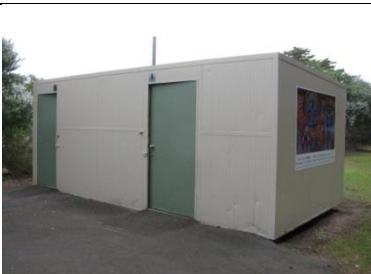
Toilet No 13 –Gas Works Skate Park - Point Lonsdale Road, Point Lonsdale

Style	Stand Alone - Traditional - Portable Type
	Age	Old
	Cubicles	3Female, 2Male, 1 Urinal, Disabled (M,F) but poor accessibility
	Other Facilities	None
	Open	24 Hours/day

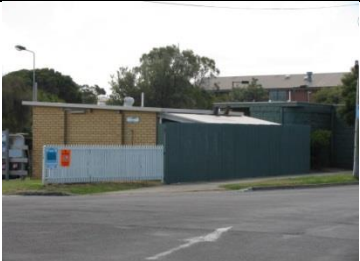
Toilet No 8 –Queenscliff Recreation Reserve – Hesse Street, Queenscliff

Style	Attached to Amenities Block –(No Disabled)
	Age	Very Old
	Cubicles	3Female, 2 Male, Urinal,
	Other Facilities	Soap, Hand Dryers, Change with bench in one toilet (each M&F), (No Disabled)
	Open	24 Hours/day

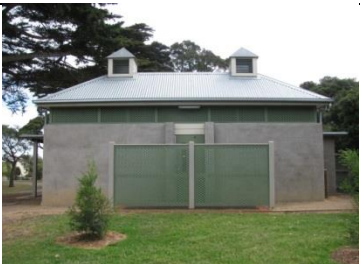
Toilet No 5 –Victoria Park – King Street, Queenscliff

Style	Incorporated Amenities Block - Unisex Disabled cubicle direct access
	Age	New
	Cubicles	1Unisex Disabled,
	Other Facilities	Shower with bench, Baby change, Hand Dryer, Mirror
	Open	24 Hours/day

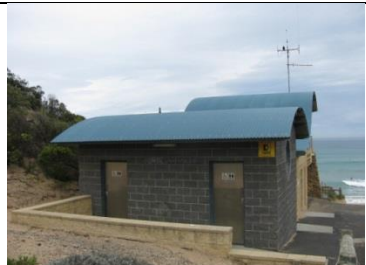
Toilet No 10 –Point Lonsdale Back Beach – Ocean Road, Point Lonsdale

Style	Incorporated with Surf Life Saving Clubrooms - Unisex Disabled cubicle direct access
	Age	New
	Cubicles	2Unisex Disabled,
	Other Facilities	Change bench & coat hooks, Mirror
	Open	24 Hours/day

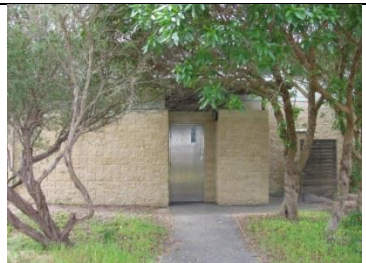
Toilet No 4 –Santa Casa Beach – Henry Street, Queenscliff

Style	Incorporated with Surf Life Saving Clubrooms - Unisex Disabled cubicle direct access
	Age	New
	Cubicles	1Unisex Disabled,
	Other Facilities	Change bench, Mirror
	Open	24 Hours/day

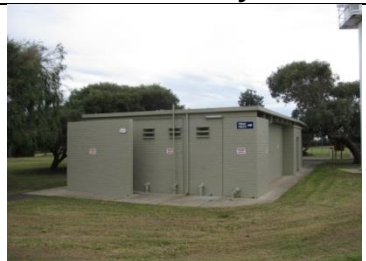
Toilet No 14 –Royal Park – King Street, Queenscliff

Style	Incorporated with Amenities Block – Male and Female Separate Units – Direct Access
	Age	Old
	Cubicles	1Male, 1 Female 1Unisex Disabled (not Open),
	Other Facilities	None
	Open	24 Hours/day

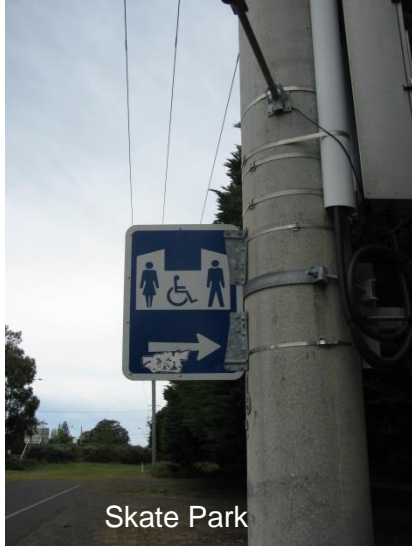
Inspection of the public toilets identified the lack of signage giving direction to the location of the nearest toilet.

Current signage is ad hoc and as people usually only visit a public toilet as a last resort, or may have planned an outing based on a map of the toilets, the ability to actually locate the nearest toilet is essential.

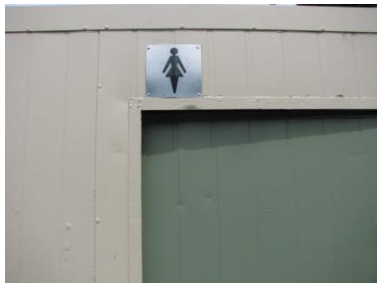
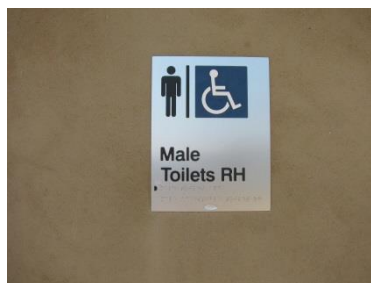
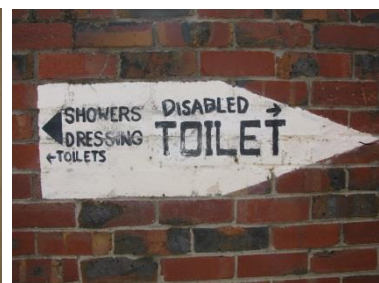
Stand-alone public toilets, unless easily identified as a public toilet, and pavilion type public toilet collocated with another building should have a sign 'Public Toilet' clearly visible on the building.

The cubicles doors are currently signed with a variety of styles. To assist identification, the cubicle doors should have standardised and clear identity signage.

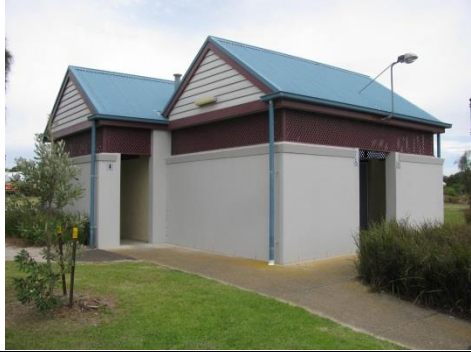
Public Toilet No. 1	Description & Location:
		JL Jordan Reserve – Boat Ramp Hesse Street Extension Queenscliff (Open 24 Hours)

No	Element	Raw Score	Risk Weight	Wtd Score	Features /Observations
Physical - (Design and Fit Out)					
1	Building Style - Adequacy of protection from weather	1	3	1	Newer traditional style with roof over all
2	Utilisation - User Demand	5	2	3	Boat ramp
3	Adequacy and Condition of fittings & fixtures for personal comforts	3	3	3	<ul style="list-style-type: none"> • Toilet bowls (3F, 3M) • toilet paper • hand washing water • sanitary (F) and Bin (F&M) • Showersx2 • Very Good Condition
4	Accessibility - Suitability for people with a Disability (particularly wheel chair)	2	4	3	<ul style="list-style-type: none"> • signed, • door widths (850), • cubicle size- old 2000 x 1600) • handrails
Physical – Location & Direction					
5	Proximity to other Public Toilet facilities	3	1	2	400
6	Siting Convenience – proximity to user generators	1	2	1	At boat ramp
7	Signage - to direct people to toilet	5	3	4	No Signage
8	Signage- identification of Toilet Facility and M,F,U,D	1	2	1	Yes

- Directional signage to toilet

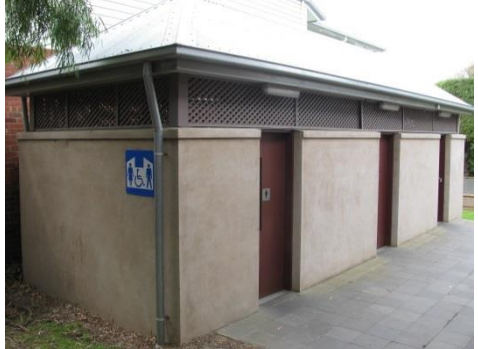
Public Toilet No. 2	Description & Location:
		Hesse Street Hesse Street Queenscliff (Open 24 hours)

No	Element	Raw Score	Risk Weight	Wtd Score	Features /Observations
Physical - (Design and Fit Out)					
1	Building Style - Adequacy of protection from weather	1	3	1	Newer traditional style with roof over all
2	Utilisation - User Demand	4	2	3	Shops and businesses in main street
3	Adequacy and Condition of fittings & fixtures for personal comforts	2	3	3	<ul style="list-style-type: none"> Toilet bowls (3F, 1M, 1D) Urinal (3M) toilet paper (All) hand washing water (2M&2D&1D) sanitary (F&D) and Bin (F&D) Mirror (F&M&D) Baby Change (D) Very Good Condition
4	Accessibility - Suitability for people with a Disability (particularly wheel chair)	2	4	3	<ul style="list-style-type: none"> signed, door widths (850), cubicle size- (old 2000 x 1600) handrails
Physical – Location & Direction					
5	Proximity to other Public Toilet facilities	3	1	2	350
6	Siting Convenience – proximity to user generators	1	2	1	At shopping/commercial centre

- Directional signage needs better arrow
- Doors hard to open (heavy)
- Dark when first enter even though seems to be good natural light
- Lighting of walkway

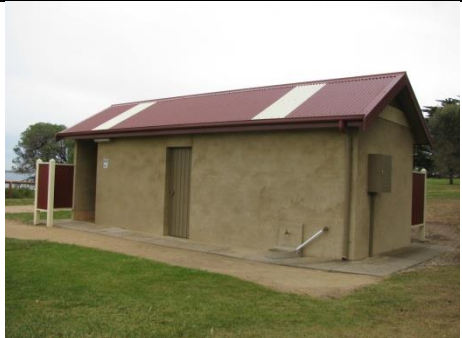
Public Toilet No. 3	Description & Location:
		Citizen's Park Gellibrand Street Queenscliff (Open 24 Hours)

No	Element	Raw Score	Risk Weight	Wtd Score	Features /Observations
Physical - (Design and Fit Out)					
1	Building Style - Adequacy of protection from weather	1	3	1	Newer traditional style with roof over all
2	Utilisation - User Demand	5	2	3	Park users, visitors to .lighthouse, beach
3	Adequacy and Condition of fittings & fixtures for personal comforts	2	3	3	<ul style="list-style-type: none"> Toilet bowls (1M/D,1F/D, 1F) Urinal (1M) toilet paper hand washing water (1M&1F) sanitary (F/D) Mirror (M&F) Sharps (M&F) Rubbish Bin (M&F) Very Good Condition
4	Accessibility - Suitability for people with a Disability (particularly wheel chair)	1	4	1	<ul style="list-style-type: none"> signed, door widths (850), cubicle size-(new2300 x 1900) handrails
Physical – Location & Direction					
5	Proximity to other Public Toilet facilities	3	1	2	350
6	Siting Convenience – proximity to user generators	1	2	1	Located at generator site

- Directional signage to toilet
- Requires Public Toilet sign on toilet facing carpark
- Access could be improved for mobility impaired
- Screens at doorways be replaced with slats or perforated metal to improve safety and ability to see cubicle doors

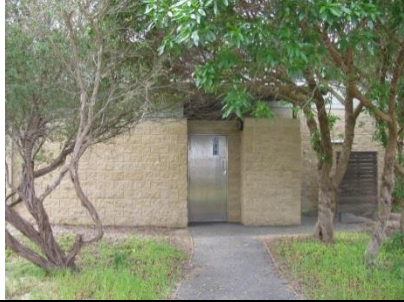
<p align="center">Public Toilet No. 4</p>	<p>Description & Location:</p>
		<p align="center">Santa Casa Beach</p> <p align="center">Henry Street Queenscliff</p> <p align="center">(Open 24 Hours)</p>

No	Element	Raw Score	Risk Weight	Wtd Score	Features /Observations
Physical - (Design and Fit Out)					
1	Building Style - Adequacy of protection from weather	1	3	1	Direct access to M/F/D attached to Club Rooms with roof covering all.
2	Utilisation - User Demand	4	2	3	Mainly beach users or down track from carpark
3	Adequacy and Condition of fittings & fixtures for personal comforts	3	3	3	<ul style="list-style-type: none"> Toilet bowls (1M/F/D) toilet paper hand washing water (1M/F/D) sanitary (M/F/D) Mirror (M/F/D) Bench Good Condition
4	Accessibility - Suitability for people with a Disability (particularly wheel chair)	1	4	1	<ul style="list-style-type: none"> signed, door widths (850), cubicle size-(new2300 x 1900) handrails
Physical – Location & Direction					
5	Proximity to other Public Toilet facilities	4	1	2	900m
6	Siting Convenience – proximity to user generators	2	2	2	Located <100m from beach & carpark

- Visibility of entrance and consequently safety is an issue
- Requires Public Toilet sign on toilet facing carpark/beach
- Building located in scrub area, although trees trimmed up possible concealment at night
- Light on building at door and side of building as access but no other lighting – needs improvement.
- Not a 24 hour toilet

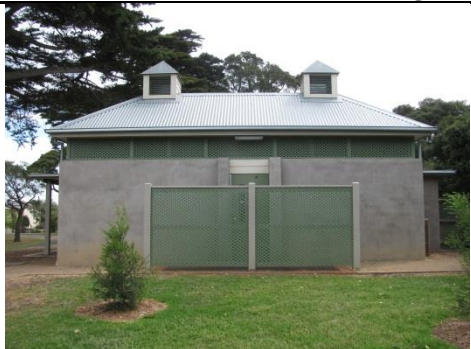
Public Toilet No. 5	Description & Location:
		Victoria Park King Street Queenscliff (Open 24 Hours)

No	Element	Raw Score	Risk Weight	Wtd Score	Features /Observations
Physical - (Design and Fit Out)					
1	Building Style - Adequacy of protection from weather	1	3	1	Direct access M/F/D attached to camp Amenities bldg. with roof covering all.
2	Utilisation - User Demand	4	2	3	Park, beach and passers by.
3	Adequacy and Condition of fittings & fixtures for personal comforts	1	3	1	<ul style="list-style-type: none"> • Toilet bowls (1M/F/D) • toilet paper • hand washing water • hand dryer • Shower with bench • sanitary • Mirror • Baby change
4	Accessibility - Suitability for people with a Disability (particularly wheel chair)	1	4	1	<ul style="list-style-type: none"> • signed, • door widths (850), • cubicle size-(new2300 x 1900) • handrails
Physical – Location & Direction					
5	Proximity to other Public Toilet facilities	3	1	2	300m
6	Siting Convenience – proximity to user generators	1	2	1	Located in Park & edge of road

- Difficulty locating from street.- requires Public Toilet sign on toilet facing park and street sign pointing to toilet
- Tree on roadside needs to be trimmed up for visibility
- Requires natural light if possible
- For 24 hours requires better access lighting

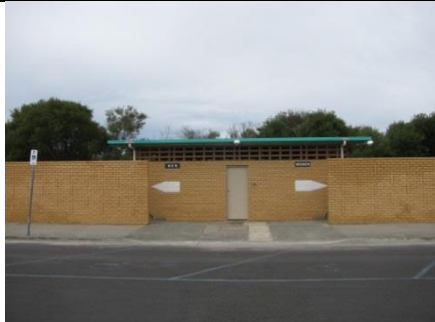
Public Toilet No. 7	Description & Location:
		Weeroona Parade Weeroona Parade Queenscliff (Open 24 Hours)

No	Element	Raw Score	Risk Weight	Wtd Score	Features /Observations
Physical - (Design and Fit Out)					
1	Building Style - Adequacy of protection from weather	3	3	3	Traditional design, roof over cubicles, urinal and wash basins, but not over change, showers and partly over entrances.
2	Utilisation - User Demand	4	2	3	Beach, walkers, buses, ferry
3	Adequacy and Condition of fittings & fixtures for personal comforts	4	3	4	<ul style="list-style-type: none"> Toilet bowls (3M (D),4F + 1 D Urinal (M)) toilet paper hand basins (2M,2F) Showers (2M,2F) Sanitary (2F) Change with benches Just acceptable condition
4	Accessibility - Suitability for people with a Disability (particularly wheel chair)	5	4	5	<ul style="list-style-type: none"> Signed on door only, door widths (850), cubicle size small, door no handle handrail - minimum Not suitable as a Disabled Toilet
Physical – Location & Direction					
5	Proximity to other Public Toilet facilities	3	1	2	250m

- Older style toilet –design is an issue
- Safety an issue
- Lack of facilities for disabled an issue
- Fit out is tired (old)

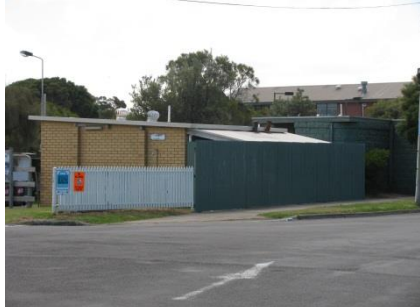
Public Toilet No. 8	Description & Location:
		Queenscliffe Recreation Reserve Hesse Street Queenscliff (Open 24 Hours)

No	Element	Raw Score	Risk Weight	Wtd Score	Features /Observations
Physical - (Design and Fit Out)					
1	Building Style - Adequacy of protection from weather	2	3	3	Traditional design incorporated with caravan park amenities. Roof over cubicles, urinal and wash basins, change and foyer.
2	Utilisation - User Demand	4	2	3	Carpark, beach, park users
3	Adequacy and Condition of fittings & fixtures for personal comforts	4	3	4	<ul style="list-style-type: none"> Toilet bowls (2M,3F) Urinal (M) toilet paper hand basins (1M,2F) Soap (M,F) Hand dryers (M,F) Mirror (1M,2F) Sanitary (3F) Change within one toilet with bench Good condition for old bldg
4	Accessibility - Suitability for people with a Disability (particularly wheel chair)	5	4	5	None
Physical – Location & Direction					
5	Proximity to other Public Toilet facilities	3	1	2	250m
6	Siting Convenience – proximity to user generators	2	2	2	Located in park not easily found by other users e.g. carpark, beach. kiosk

- Older style toilet, poorly located. Poorly orientated – hard to locate and find entrance
- Poor access
- No disability toilet

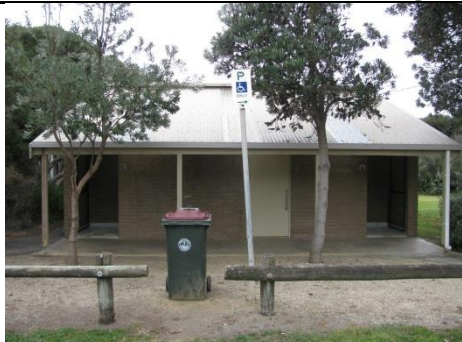
Public Toilet No. 9	Description & Location:
		Ganes Reserve Ocean Road Point Lonsdale (Open 24 Hours)

No	Element	Raw Score	Risk Weight	Wtd Score	Features /Observations
Physical - (Design and Fit Out)					
1	Building Style - Adequacy of protection from weather	1	3	1	Newer traditional style with roof over all facilities and entrances. Has M with direct access
2	Utilisation - User Demand	3	2	3	Park, occasional beach and bus users
3	Adequacy and Condition of fittings & fixtures for personal comforts	3	3	3	<ul style="list-style-type: none"> • Toilet bowls (4F, 3M, 1D) • Urinal (M) • toilet paper • hand basins (2M,2F) • sanitary (2F) • Change table bench (F) • Good Condition
4	Accessibility - Suitability for people with a Disability (particularly wheel chair)	2	4	3	<ul style="list-style-type: none"> • signed, • door widths (850), • cubicle size- old (2000 x 1600) • single handrails not to std
Physical – Location & Direction					
5	Proximity to other Public Toilet facilities	3	1	2	250
6	Siting Convenience – proximity to user generators	3	2	3	At park but some distance from the beach, but where beach users park cars

- Traditional design for M7F – safety issues
- Access could be improved - gravel
- Disabled needs updating
- Signage to toilet
- External lighting

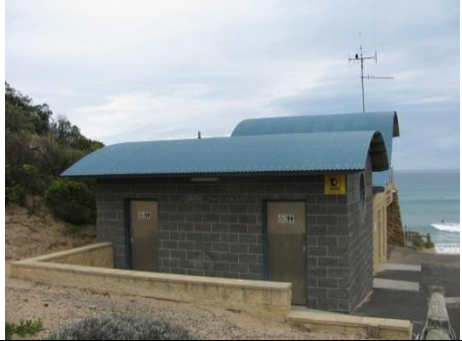
Public Toilet No. 10	Description & Location:
		Point Lonsdale Back Beach Ocean Road Point Lonsdale (Open 24 Hours)

No	Element	Raw Score	Risk Weight	Wtd Score	Features /Observations
Physical - (Design and Fit Out)					
1	Building Style - Adequacy of protection from weather	1	3	1	Direct access to 2 no. M/F/D within Surf Club building with roof overhanging entrances l.
2	Utilisation - User Demand	4	2	3	Mainly beach users regular use
3	Adequacy and Condition of fittings & fixtures for personal comforts	3	3	3	<ul style="list-style-type: none"> Toilet bowls (2M/F/D) toilet paper hand washing water (1M/F/D) sanitary (M/F/D) Mirror (M/F/D) Bench and coat hooks Good Condition
4	Accessibility - Suitability for people with a Disability (particularly wheel chair)	1	4	1	<ul style="list-style-type: none"> signed, door widths (850), cubicle size-(new2300 x 1900) handrails
Physical – Location & Direction					
5	Proximity to other Public Toilet facilities	3	1	2	250m
6	Siting Convenience – proximity to user generators	1	2	1	Located at generator site

- External Lighting
- Deep clean

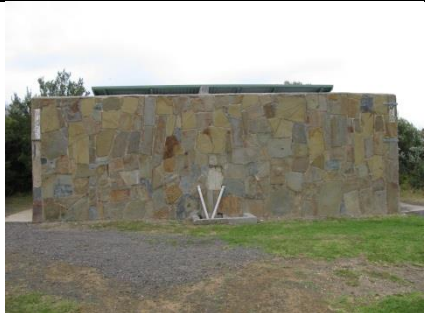
Public Toilet No. 11	Description & Location:
		Lighthouse Reserve Point Lonsdale Road Point Lonsdale (Open 24 Hours)

No	Element	Raw Score	Risk Weight	Wtd Score	Features /Observations
Physical - (Design and Fit Out)					
1	Building Style - Adequacy of protection from weather	4	3	4	Old traditional with no roof over entrances, wash basins, Only roofed over cubicles.
2	Utilisation - User Demand	4	2	3	Reserve, lighthouse, jetty.
3	Adequacy and Condition of fittings & fixtures for personal comforts	5	3	4	<ul style="list-style-type: none"> Toilet bowls (1M,2F) Urinal (M) toilet paper hand washing basins (1M,1F) Sanitary (1F) very old, poor condition & repair
4	Accessibility - Suitability for people with a Disability (particularly wheel chair)	5	4	5	<ul style="list-style-type: none"> None
Physical – Location & Direction					
5	Proximity to other Public Toilet facilities	4	1	2	500m
6	Siting Convenience – proximity to user generators	1	2	1	Located at generator site
7	Signage - to direct people to toilet	5	3	4	No Signage
8	Signage- identification of Toilet Facility and M,F,U,D	4	2	3	Hand written signage, very poor

- Demolish

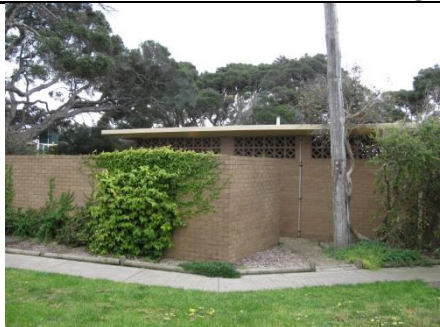
Public Toilet No. 12	Description & Location:
		Point Lonsdale Foreshore Point Lonsdale Road Point Lonsdale (Open 24 Hours)

No	Element	Raw Score	Risk Weight	Wtd Score	Features /Observations
Physical - (Design and Fit Out)					
1	Building Style - Adequacy of protection from weather	3	3	3	Traditional design, roof over cubicles, urinal and wash basins, but not over change, showers and entrances.
2	Utilisation - User Demand	4	2	3	Beach, playground, shopping centre
3	Adequacy and Condition of fittings & fixtures for personal comforts	4	3	4	<ul style="list-style-type: none"> • Toilet bowls (2M ,4F) • Urinal (M)) • toilet paper • hand basins (M,F) • Showers (2M,2F) • Sanitary (2F) + Bin • Change with benches • Just acceptable condition
4	Accessibility - Suitability for people with a Disability (particularly wheel chair)	5	4	5	<ul style="list-style-type: none"> • None
Physical – Location & Direction					
5	Proximity to other Public Toilet facilities	3	1	2	250m
6	Siting Convenience – proximity to user generators	1	2	1	Located in shop street, at beach and playground

- Being replaced. New design underway

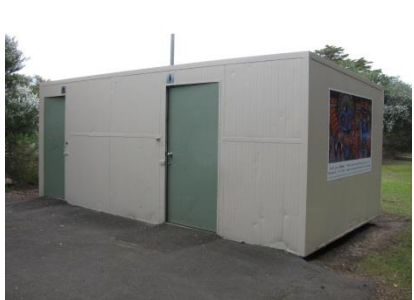
Public Toilet No. 13	Description & Location:
		Gas Works Skate Park Point Lonsdale Road Point Lonsdale (Open 24 Hours)

No	Element	Raw Score	Risk Weight	Wtd Score	Features /Observations
Physical - (Design and Fit Out)					
1	Building Style - Adequacy of protection from weather	2	3	3	Traditional layout portable style toilet with roof over cubicles, urinal and wash basins, but not over entrances.
2	Utilisation - User Demand	3	2	3	Skate Park (Peak Uses), walkers
3	Adequacy and Condition of fittings & fixtures for personal comforts	5	3	4	<ul style="list-style-type: none"> Toilet bowls (2M ,3F +DM,F) Urinal (M) toilet paper hand basins (2M,2F) Barely acceptable condition
4	Accessibility - Suitability for people with a Disability (particularly wheel chair)	4	4	4	<ul style="list-style-type: none"> Cubicles provided but not suitable and access poor
Physical – Location & Direction					
5	Proximity to other Public Toilet facilities	4	1	2	700m
6	Siting Convenience – proximity to user generators	1	2	1	Located at skate park and on walking path .

- D toilet not suitable facility
- External lighting
- Vegetation trimming
- Building Orientation
- Design (traditional)
- Old and tired interior

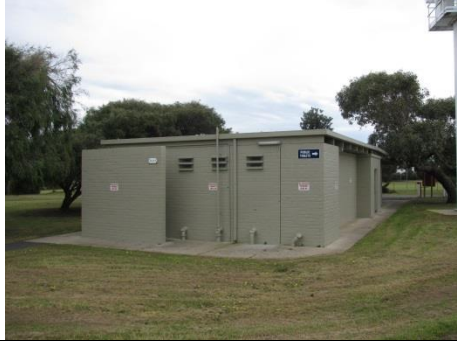
Public Toilet No. 14	Description & Location:
		Royal Parade Point Lonsdale Road Point Lonsdale (Open 24 Hours)

No	Element	Raw Score	Risk Weight	Wtd Score	Features /Observations
Physical - (Design and Fit Out)					
1	Building Style - Adequacy of protection from weather	1	3	3	M and F and D (although kept locked) External access M & F & D toilet with roof over cubicles, and entrances
2	Utilisation - User Demand	3	2	3	Walkers and park
3	Adequacy and Condition of fittings & fixtures for personal comforts	4	3	4	<ul style="list-style-type: none"> Toilet bowls (1M ,1F, 1D (locked) toilet paper Shower outside of F to wash hands Barely acceptable conditions but clean
4	Accessibility - Suitability for people with a Disability (particularly wheel chair)	5	4	4	<ul style="list-style-type: none"> Locked
Physical – Location & Direction					
5	Proximity to other Public Toilet facilities	4	1	2	700m
6	Siting Convenience – proximity to user generators	3	2	3	Located in park and near walking path.
7	Signage - to direct people to toilet	5	3	4	None
